COLORADO DEPARTMENT OF PUBLIC HEALTH
AND ENVIRONMENT

SITE INSPECTION

ANALYTICAL RESULTS REPORT

UPPER ANIMAS WATERSHED (CERCLIS ID # CO0001411347)

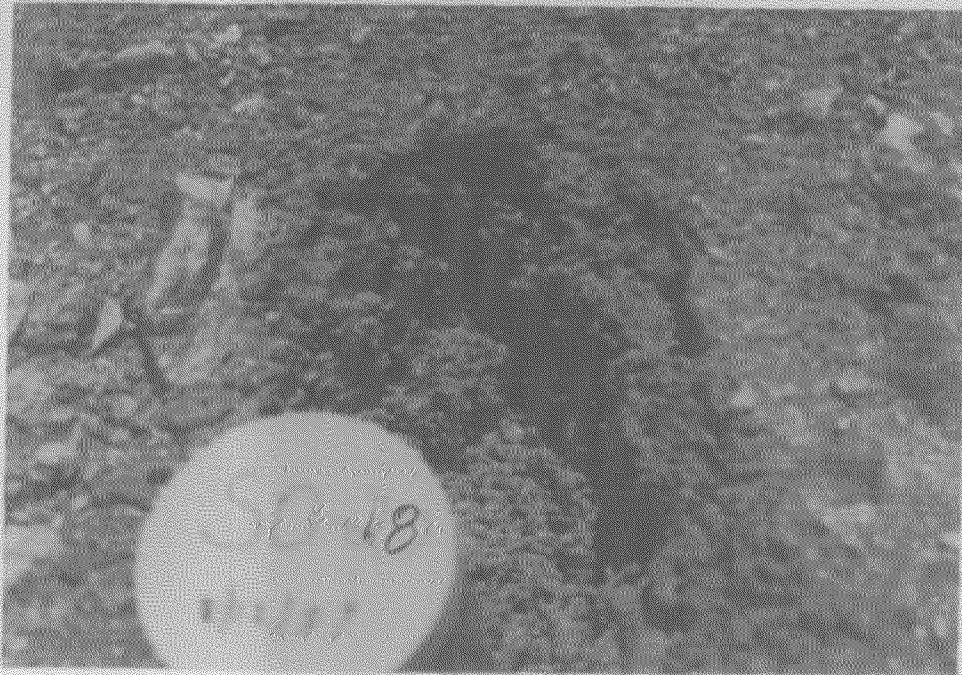
Description of Photo: SO-18 London Mine Waste pile sample
Date: August 12, 1997 Time: 1200
Direction facing: North (35mm film)

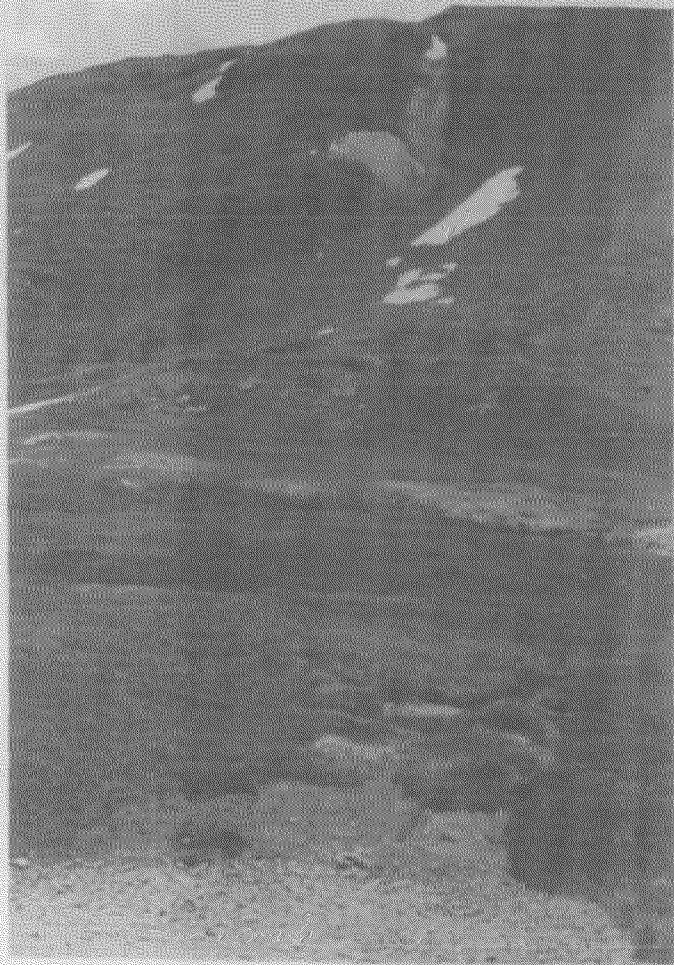
Description of Photo: SO-19 from London Mine Waste pile sample
Date: August 12, 1997 Time: 1200
Direction facing: South (35mm film)

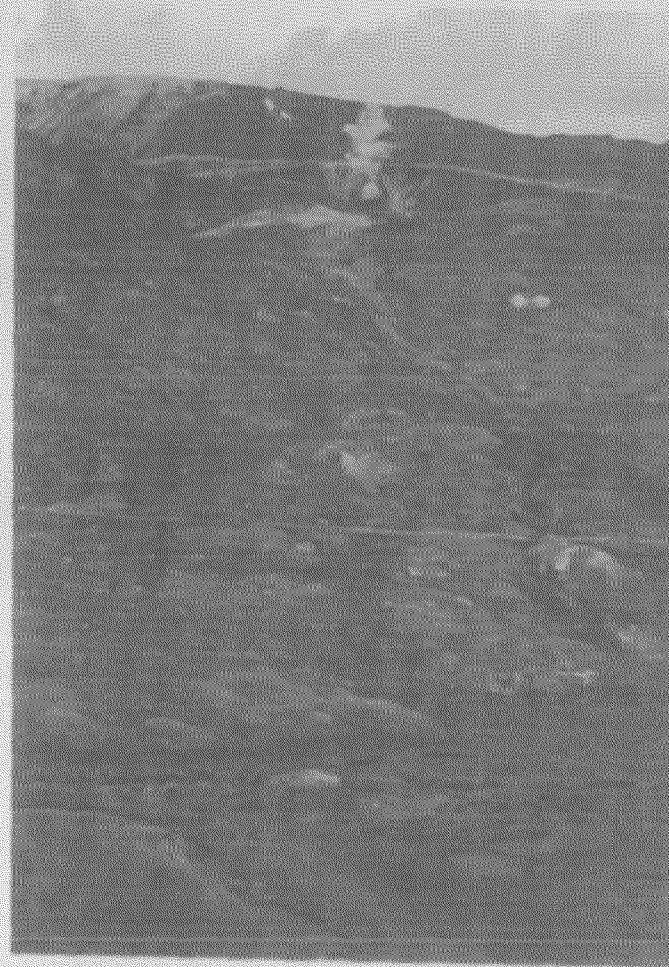
Description of Photo: SO-20 Mine Waste Pile (upper center)
Date: August 12, 1997 Time: 1215
Direction facing: North (35mm film)

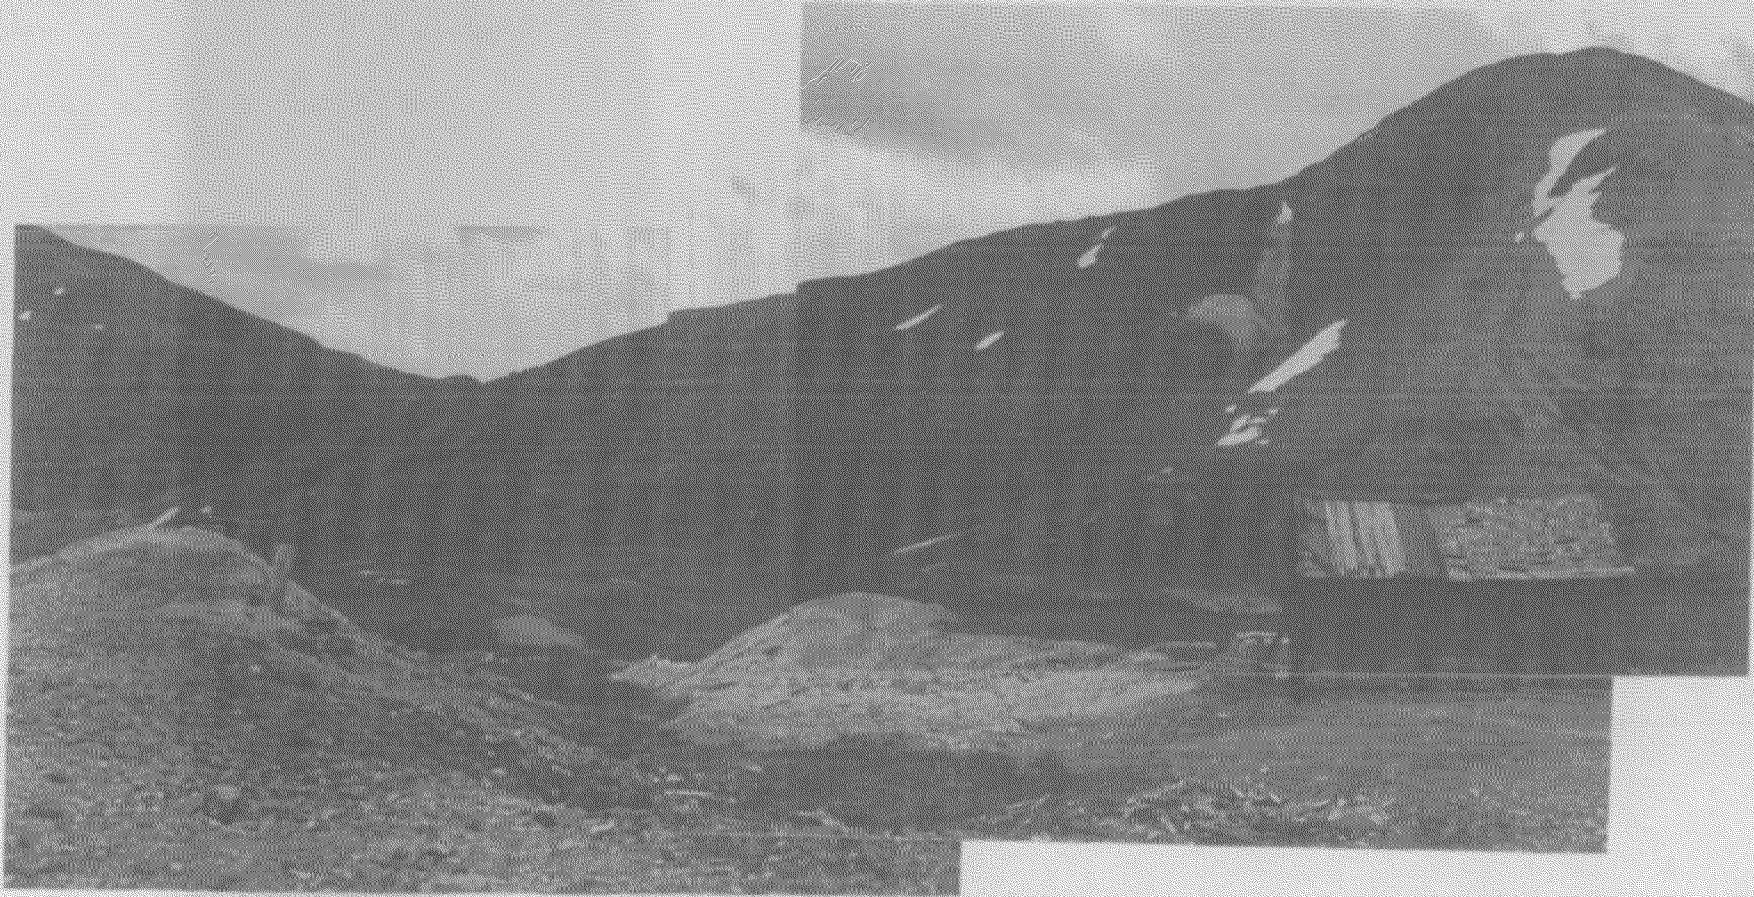
Description of Photo: 50-19 Waste Pile from the London Mine
Date: August 12, 1987 Time: 1200
Direction facing: South (35mm film)

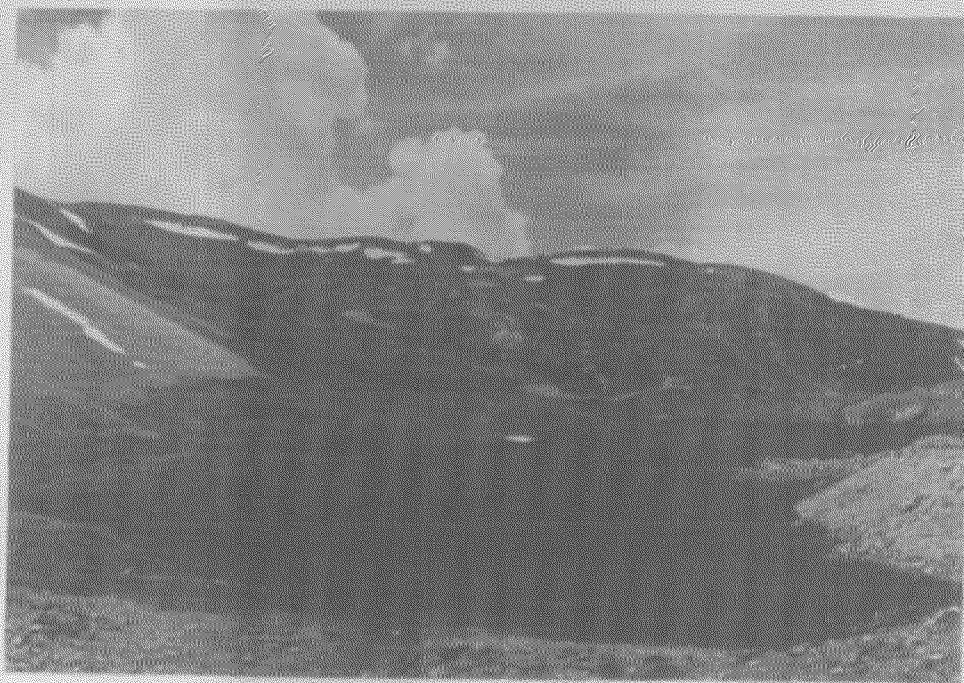
Description of Photo: SO-21 and 22 Mine Waste Piles in Burrows Gulch.
Date: August 12, 1997 Time: 1200
Direction facing: West (35mm film)

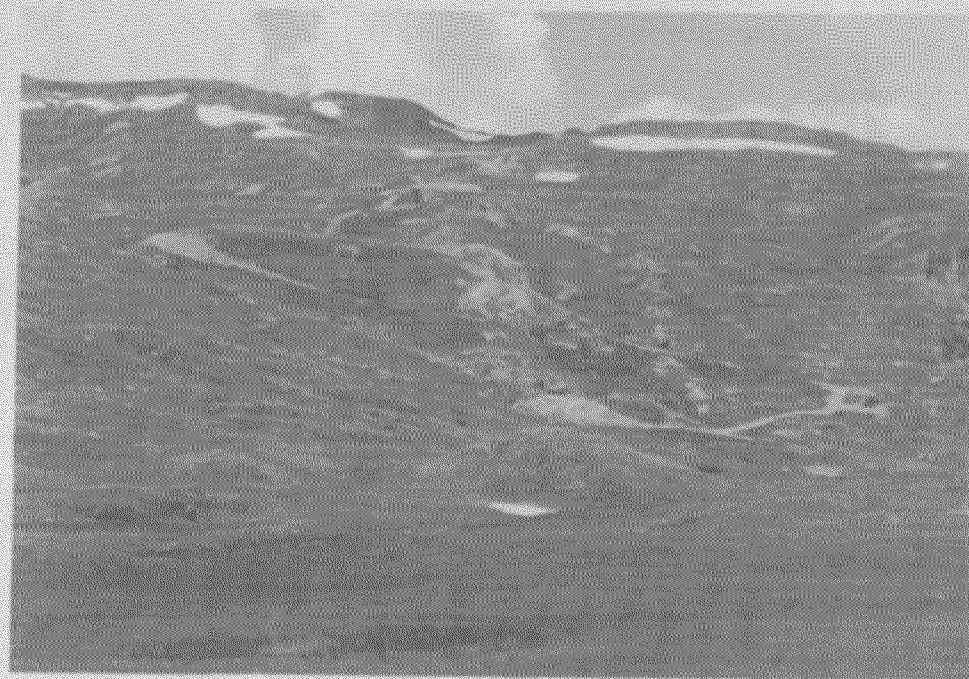
Description of Photo: SO-21 and SO-22 Mine Waste Piles in Burrows Gulch.
Date: August 12, 1997 Time: 1215
Direction facing: West (35mm film)

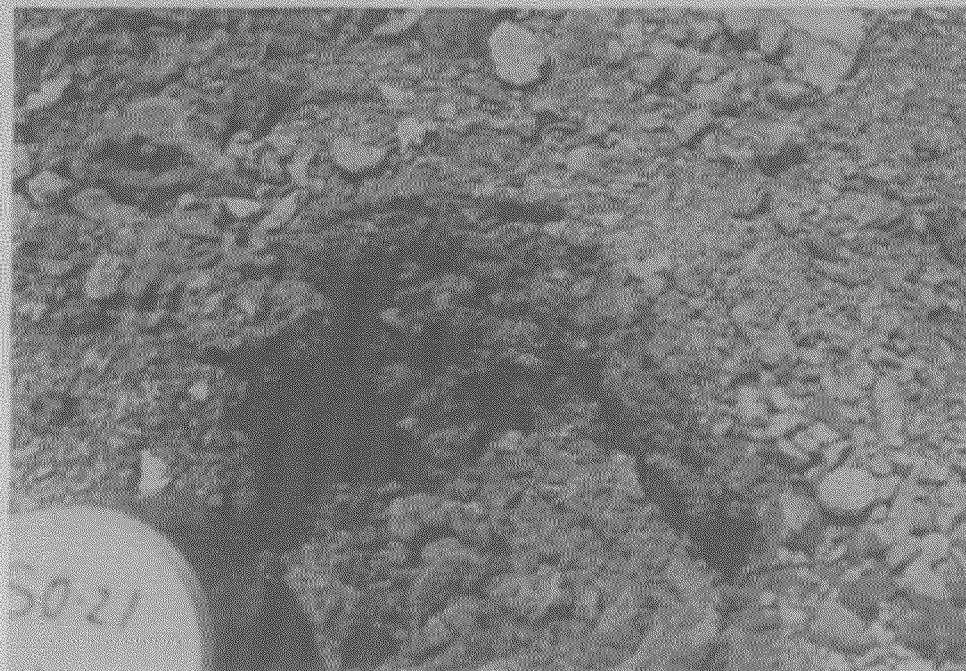
Description of Photo: SO-21 Mine Waste Sample
Date: August 12, 1997 Time: 1115
Direction facing: West (35mm film) 00

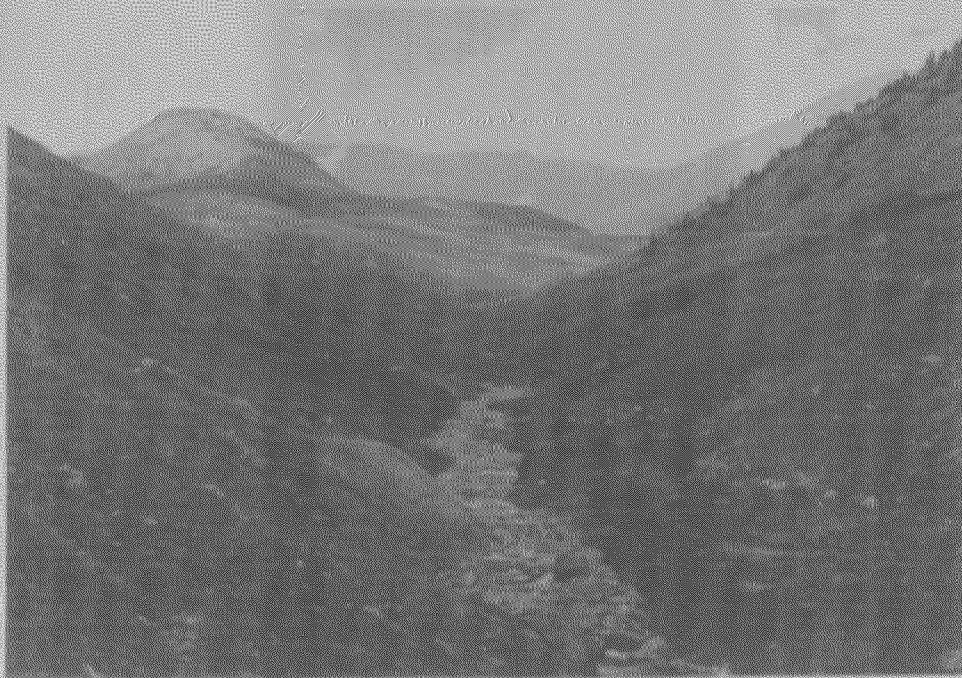
Description of Photo: SO-24 Mine waste pile
Date: August 12, 1997 Time: 1600
Direction facing: North (35mm film)

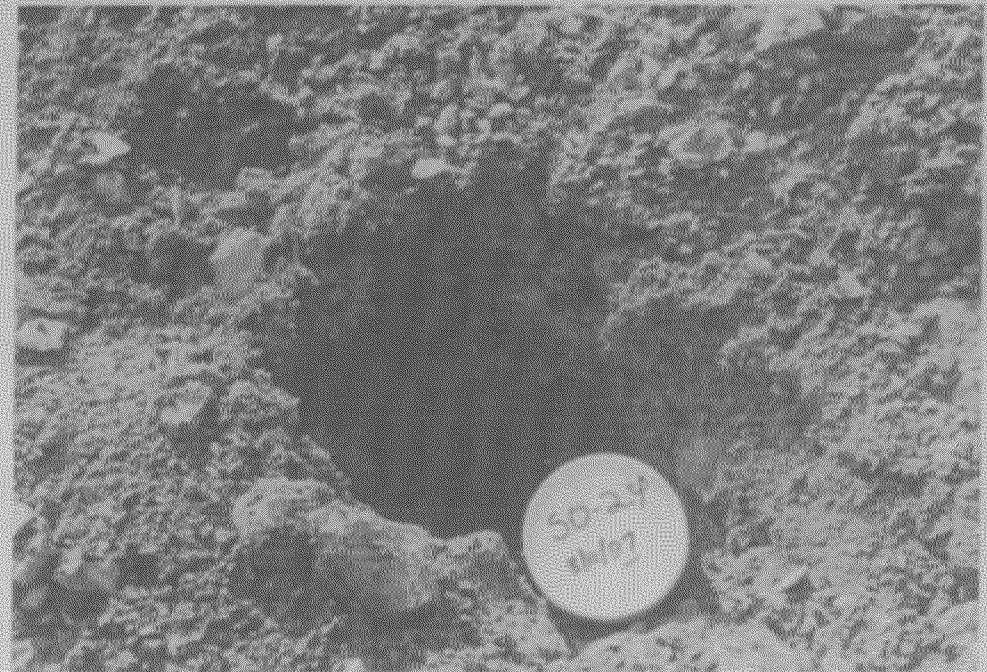
Description of Photo: SO-24 Mine waste sample
Date: August 12, 1997 Time: 1600
Direction facing: North (35mm film)

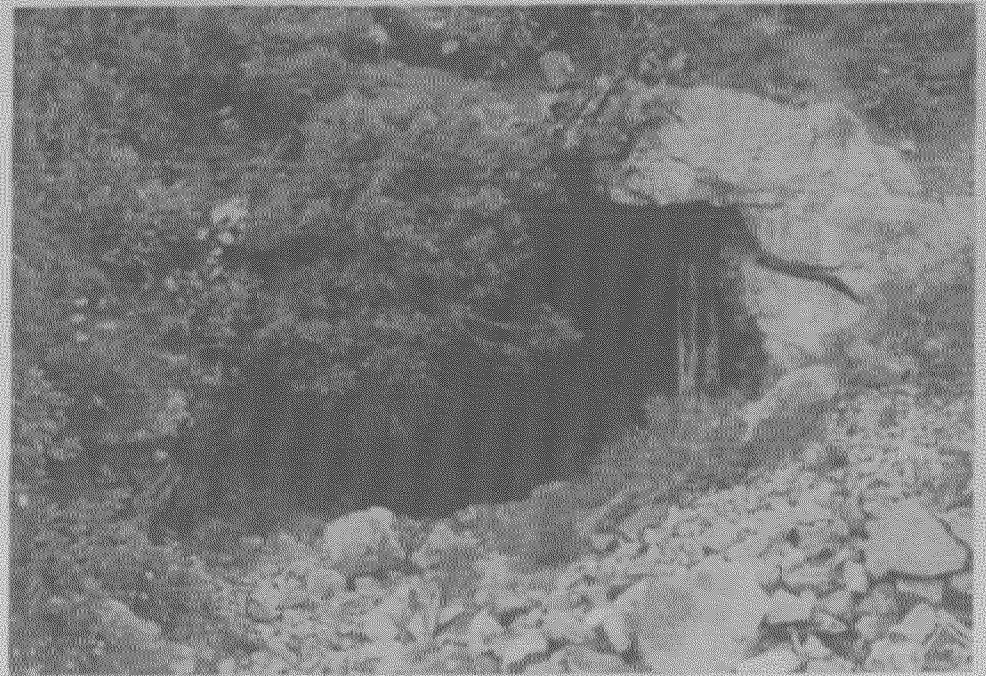
Description of Photo: SO-26 Mine portal
Date: August 12, 1997 Time: 1545
Direction facing: West (35mm film)

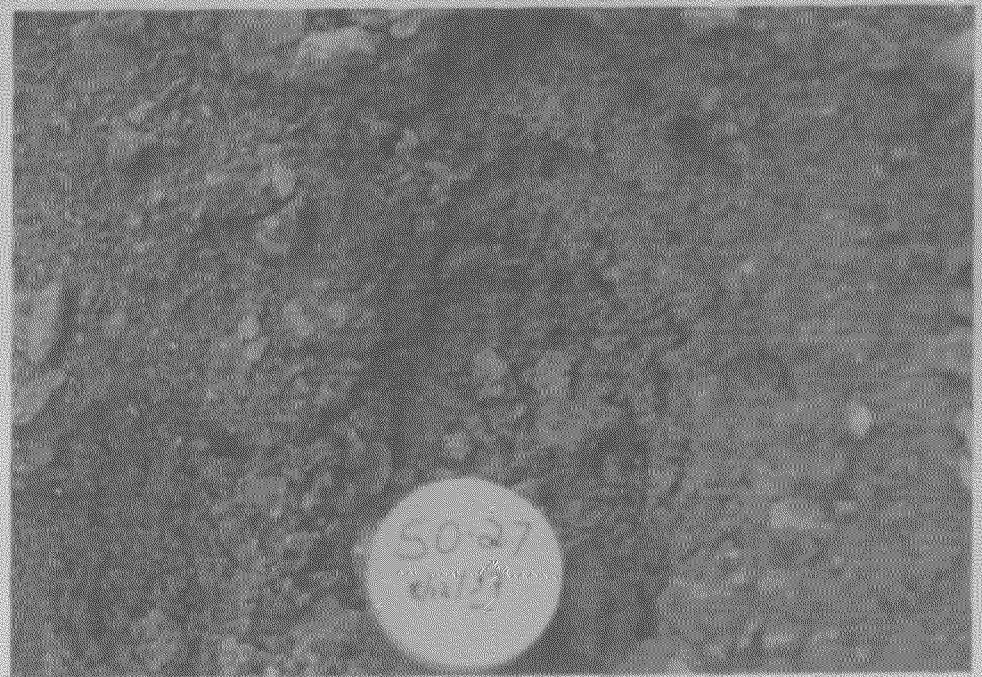
Description of Photo: SO-27 Mine waste sample
Date: August 12, 1997 Time: 1500
Direction facing: West (35mm film)

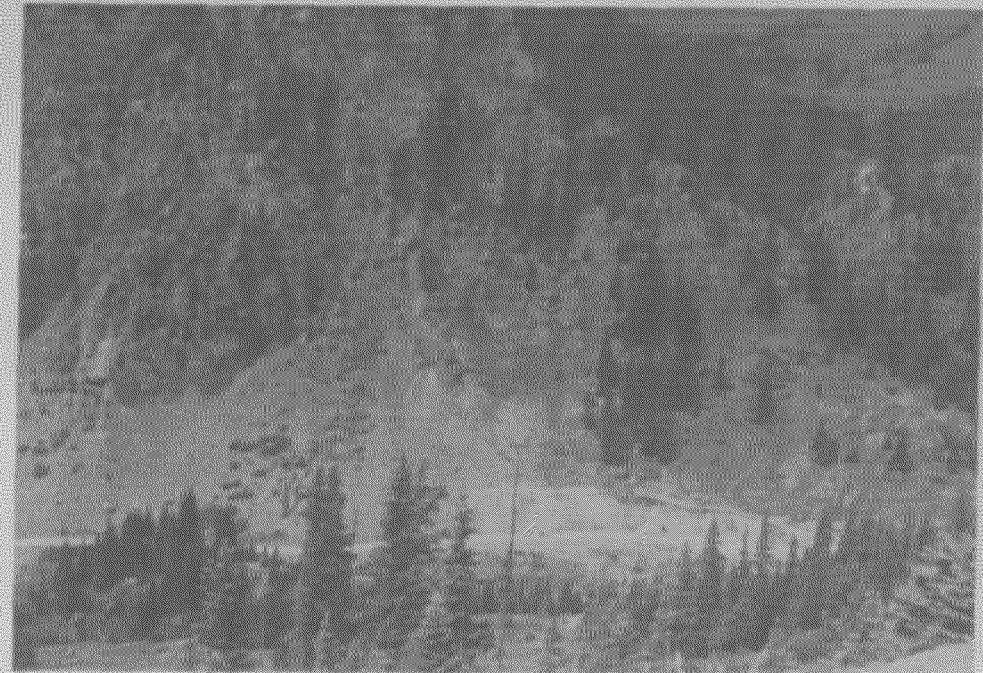
Description of Photo: SO-30 Mine Waste Pile
Date: August 13, 1997 Time: 1230
Direction facing: Northwest (35mm film)

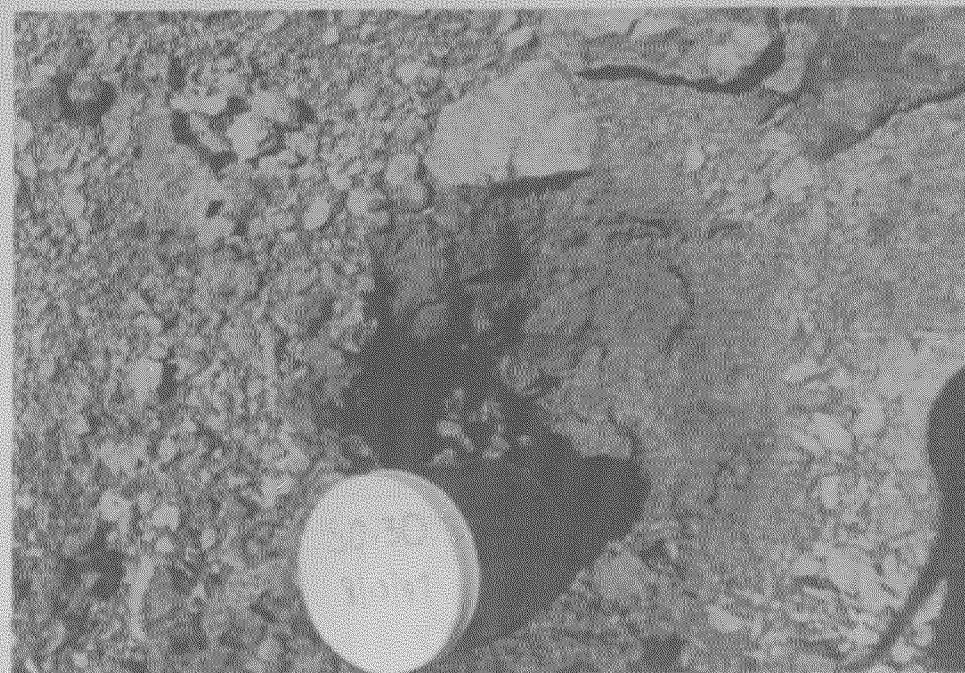
Description of Photo: SO-30 Mine Waste Sample
Date: August 13, 1997 Time: 1230
Direction facing: Northwest (35mm film)

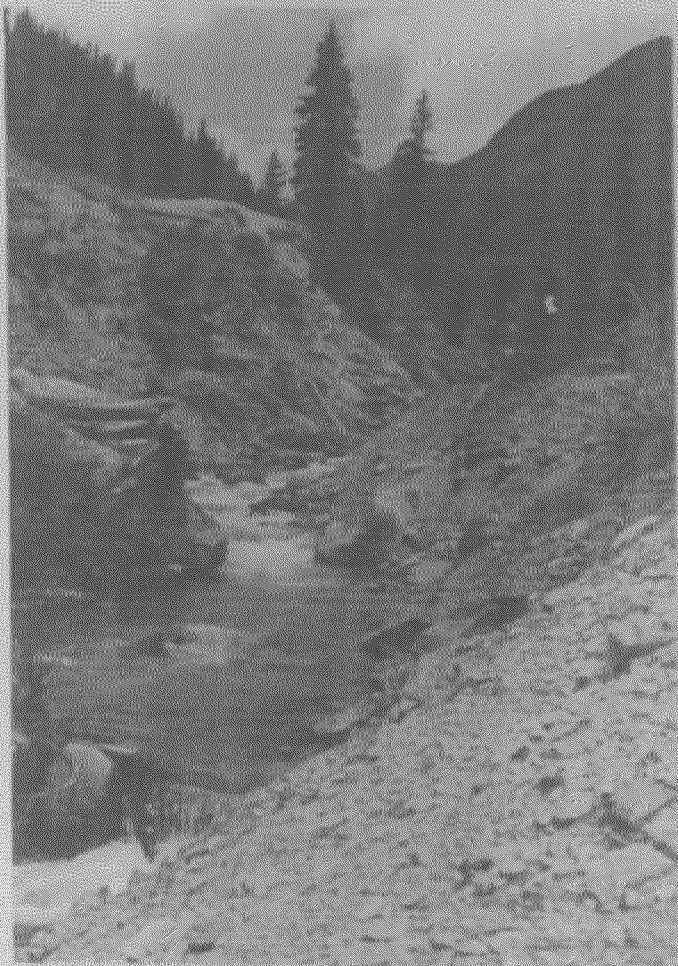
Description of Photo: SO-31 Mine Waste Pile
Date: August 13, 1997 Time: 1230
Direction facing: Southeast (35mm film)

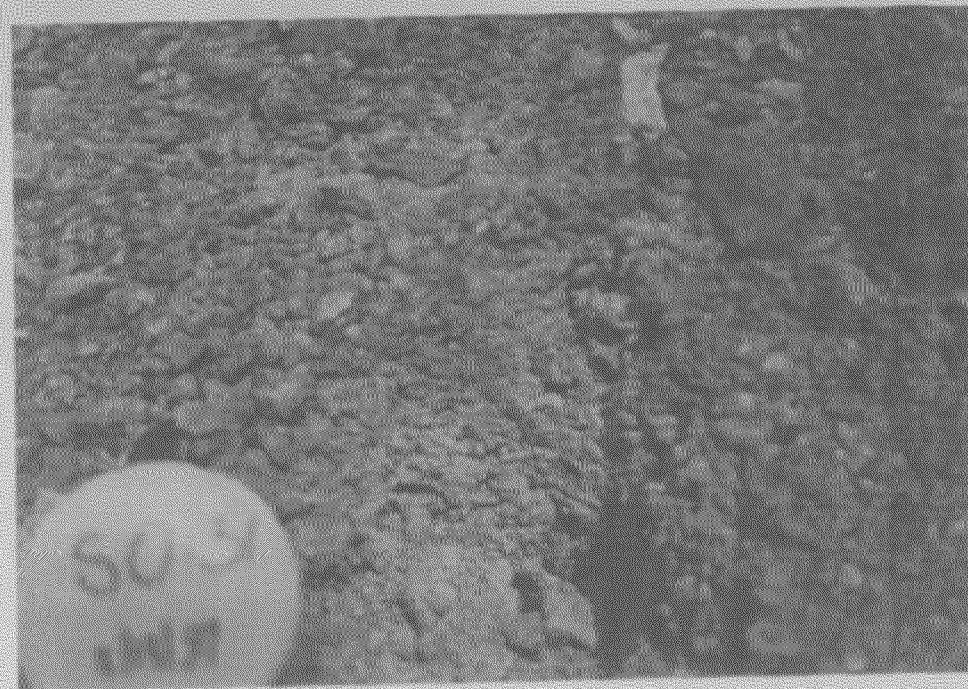
Description of Photo: SO-31 Mine Waste Sample
Date: August 13, 1997 Time: 1230
Direction facing: Northwest (35mm film)

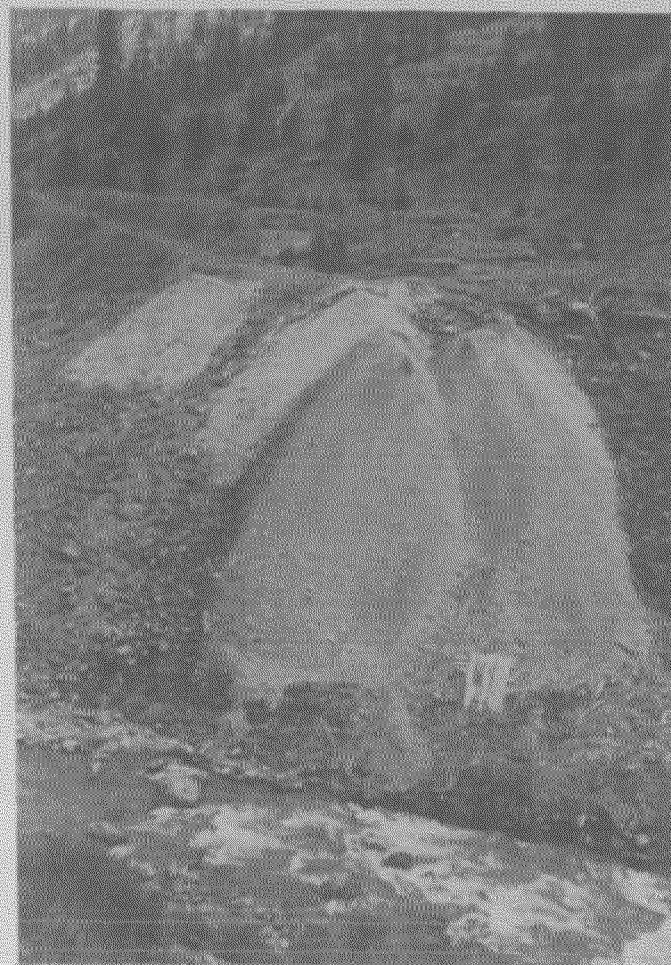
Description of Photo: SQ-33 Mine Portal
Date: August 13, 1997 Time: 1345
Direction facing: Southeast (35mm film)

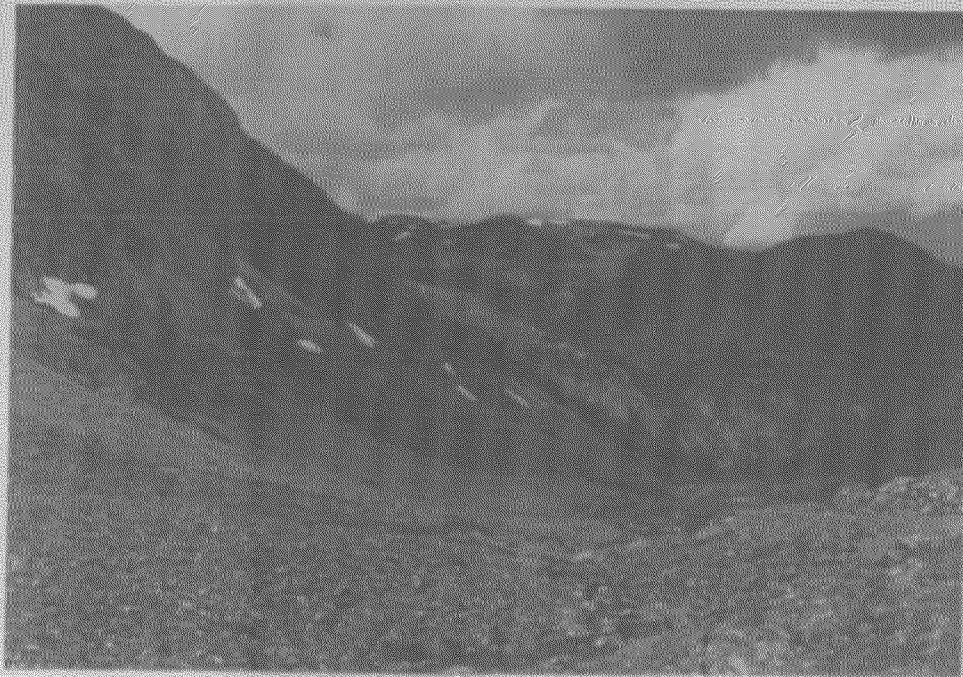
Description of Photo: SO-34 Mine Waste in Burns Gulch.
Date: August 13, 1997 Time: 1500
Direction facing: Northwest (35mm film)

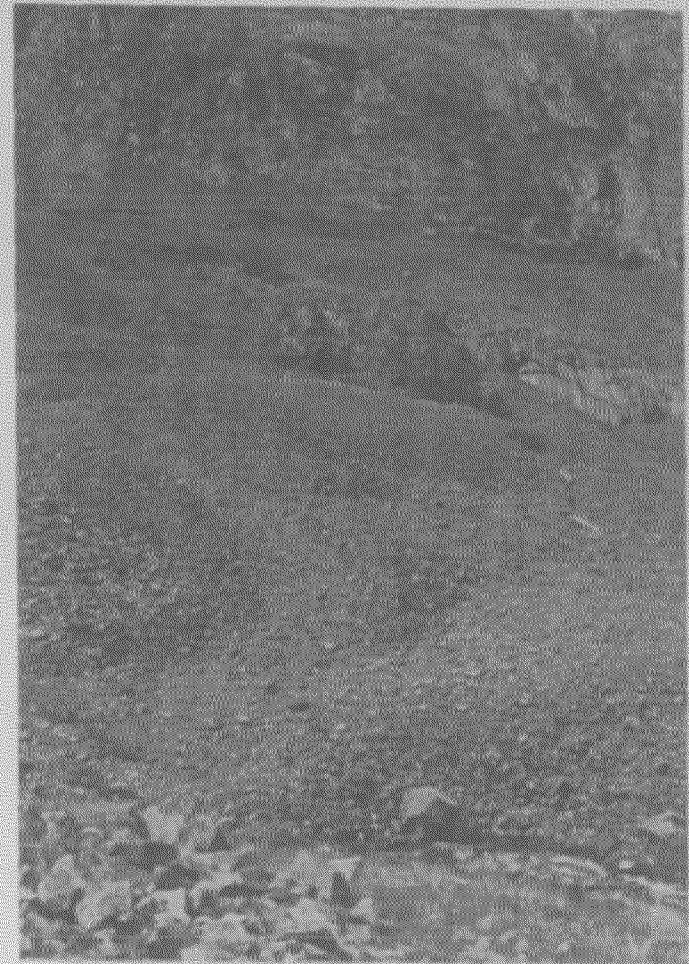
Description of Photo: SO-35 Mine Waste covered with talus (not sampled)
Date: August 13, 1997 Time: 1500
Direction facing: West (35mm film)

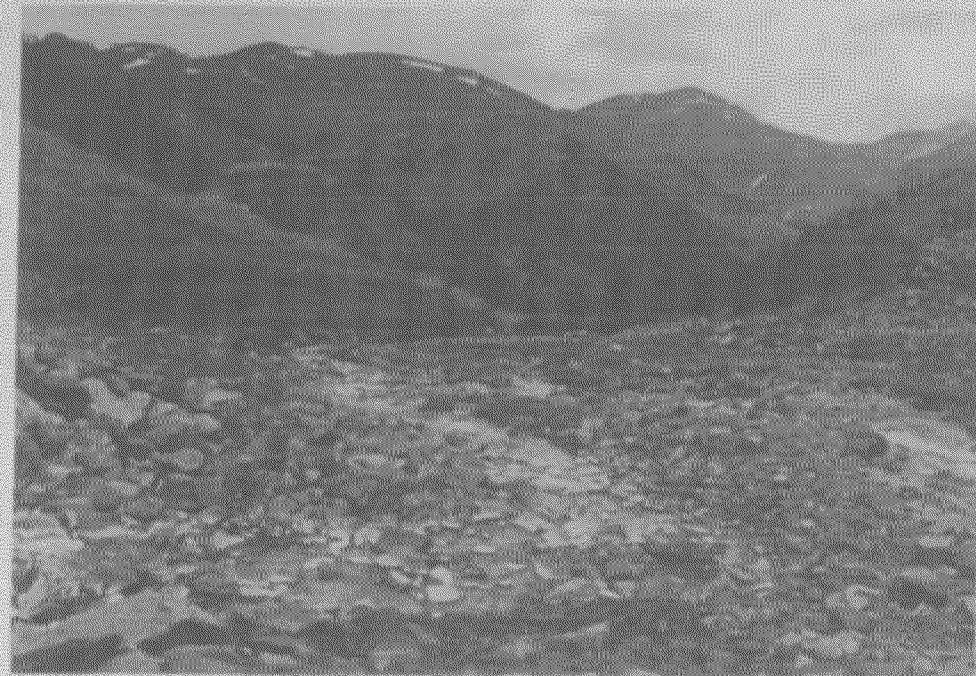
Description of Photo: OP-SE-100 Spring with white precipitate in Burns G.
Date: August 13, 1997 Time: 1330
Direction facing: Northwest (35mm film)

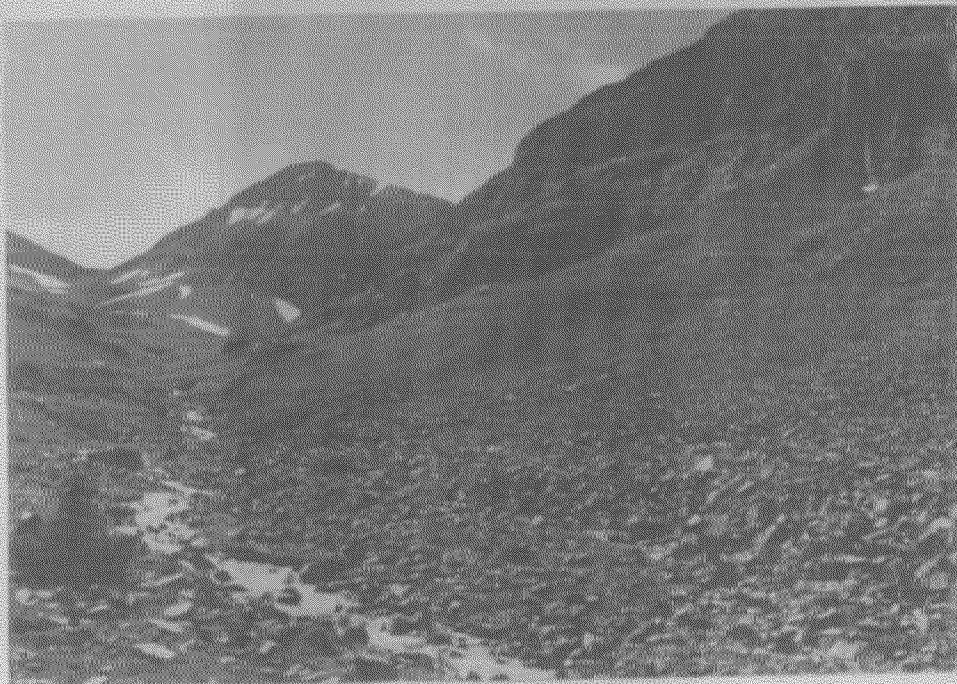
Description of Photo: OP-SE-100 Talus slope from which spring originates.
Date: August 13, 1997 Time: 1300
Direction facing: Southwest (35mm film)

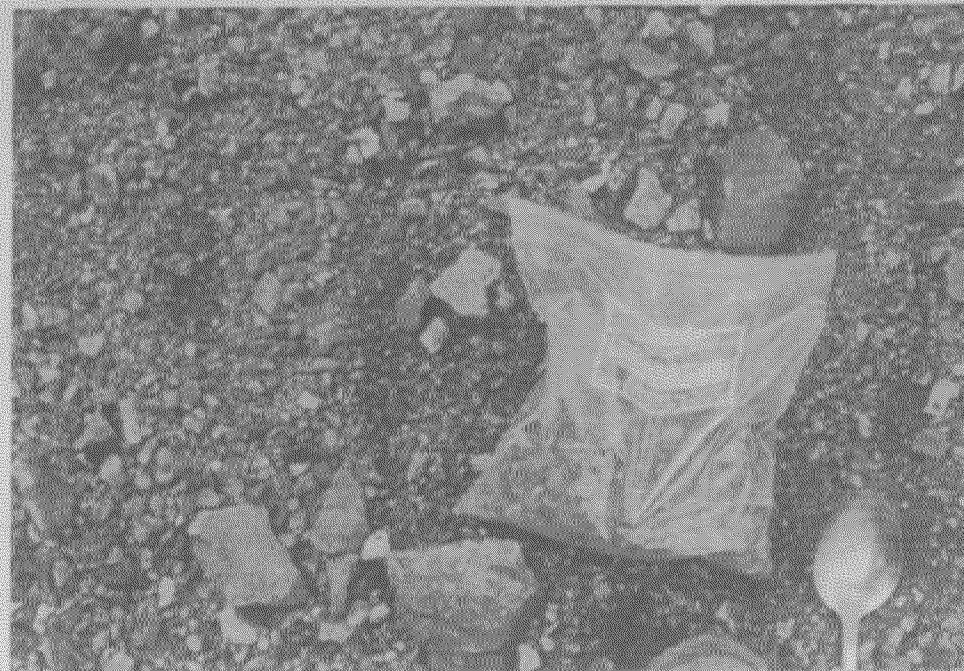
Description of Photo: OP-SE-100 Talus slope materials
Date: August 13, 1997 Time: 1300
Direction facing: Southwest (35mm film)

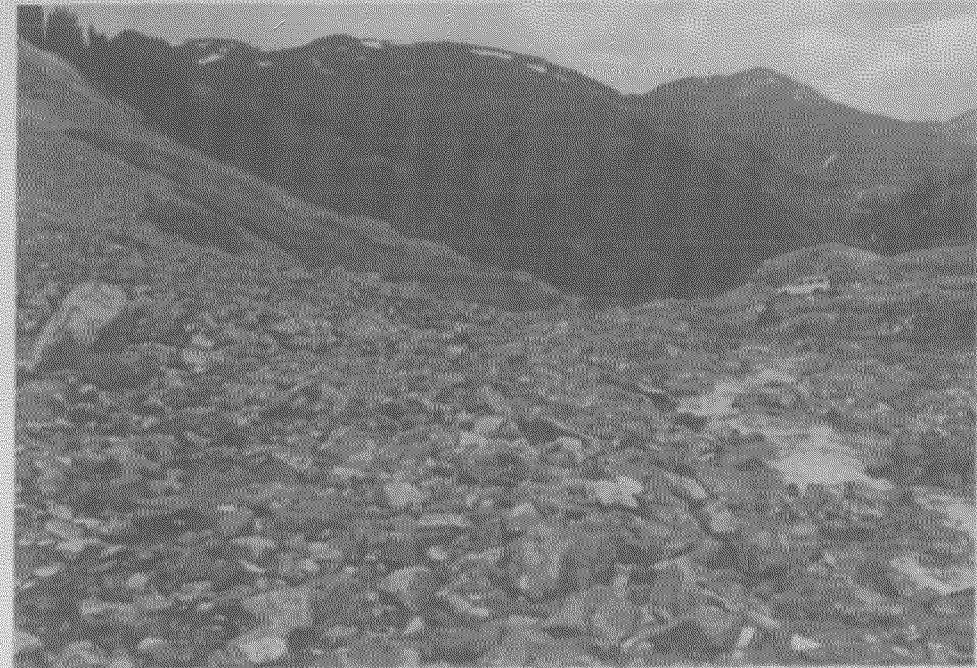
Description of Photo: OP-SE-100 Spring on left, Burns G. on right.
Date: August 13, 1997 Time: 1330
Direction facing: Southwest (35mm film)

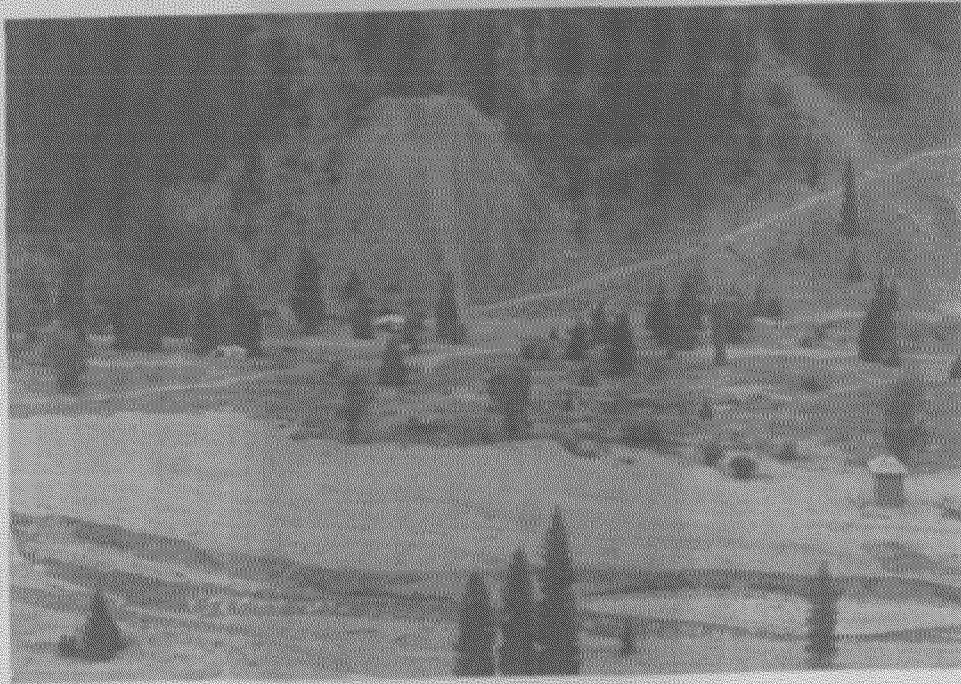
Description of Photo: SO-37 Mine waste pile south of Niagara G.
Date: August 13, 1997 Time: 1400
Direction facing: Southeast (35mm film)

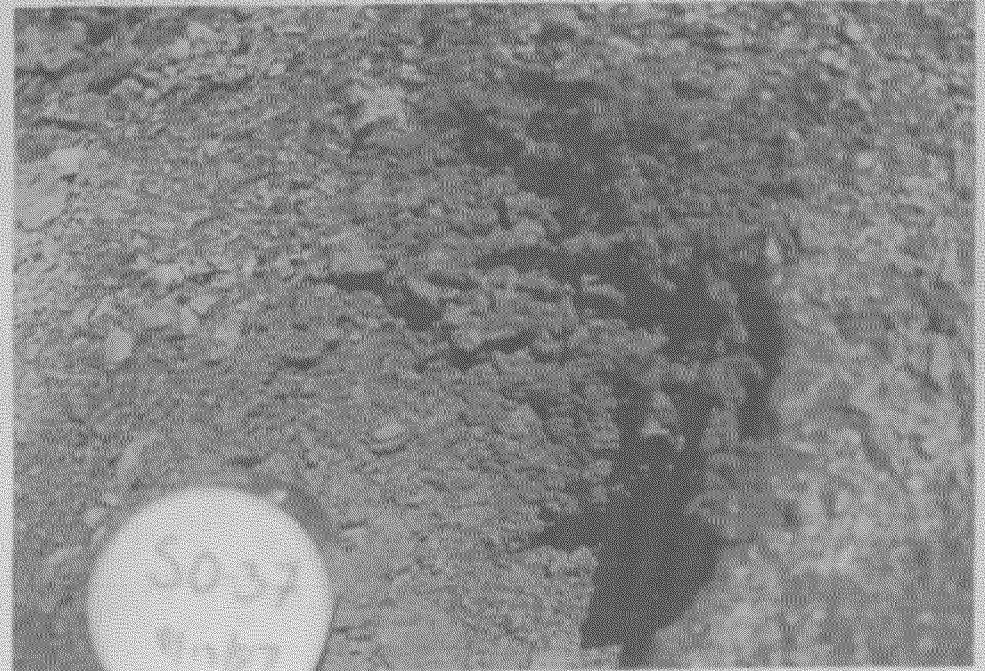
Description of Photo: SO-37 Mine Waste sample
Date: August 13, 1997 Time: 1400
Direction facing: Southeast (35mm film)

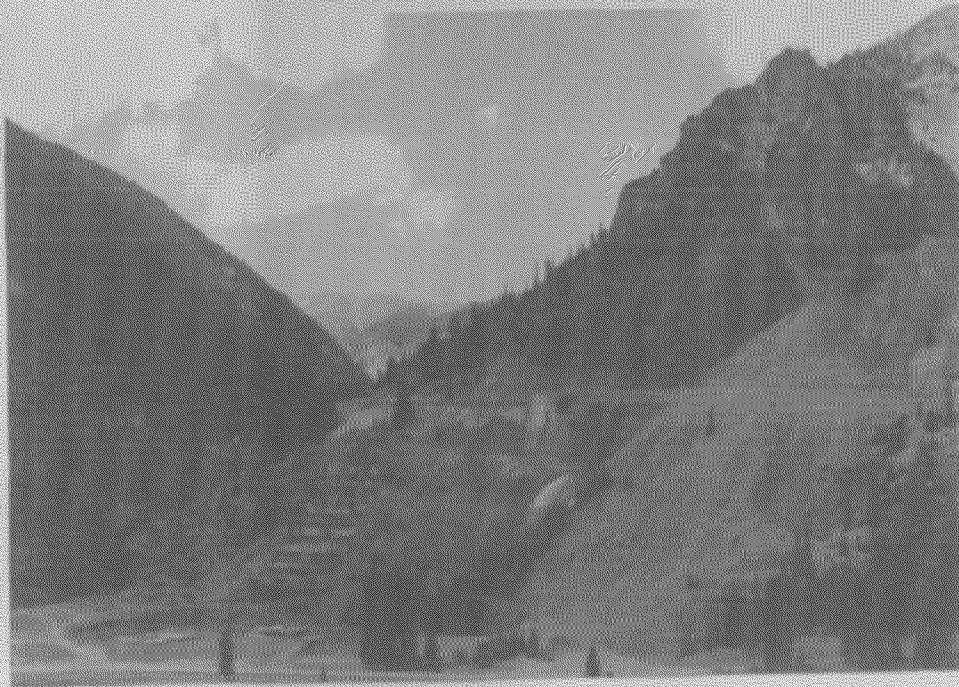
Description of Photo: SO-36 Eureka Mill Mine waste pile
Date: August 13, 1997 Time: 1400
Direction facing: Northwest (35mm film)

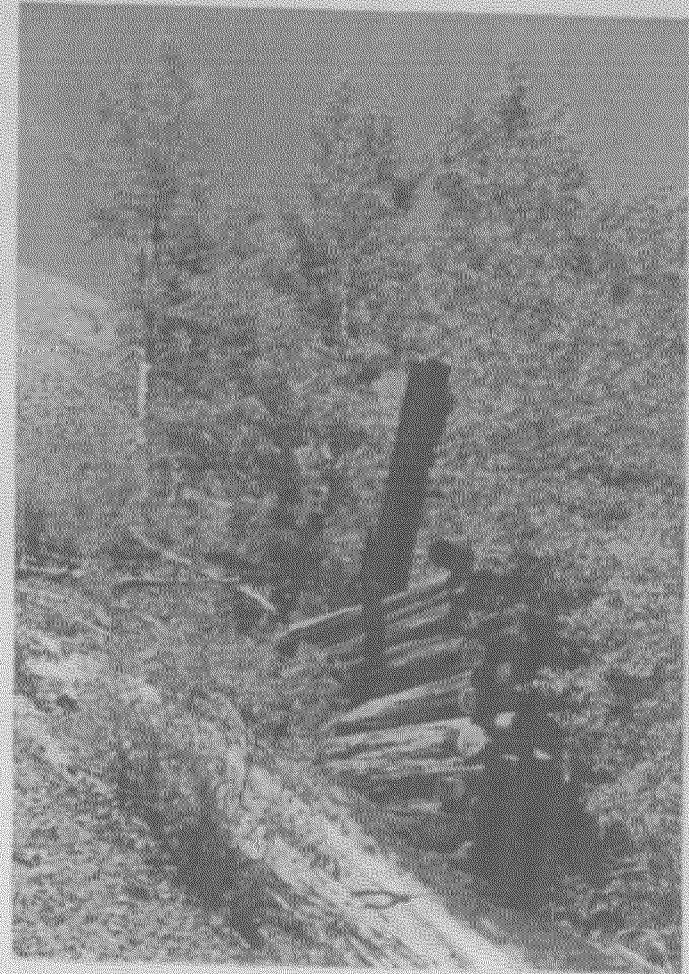
Description of Photo: SO-36 Eureka Mill Mine drainage
Date: August 13, 1997 Time: 1000
Direction facing: Northeast (35mm film)

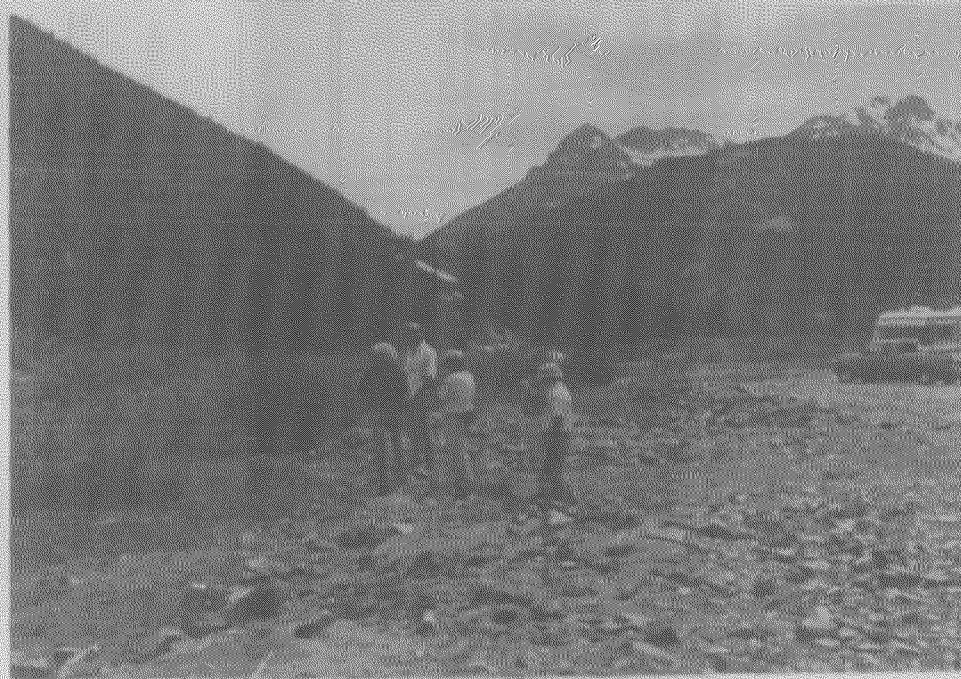
Description of Photo: GW-1 Silverton City Campground
Date: June 19, 1997 Time: 1430
Direction facing: Southwest (35mm film)

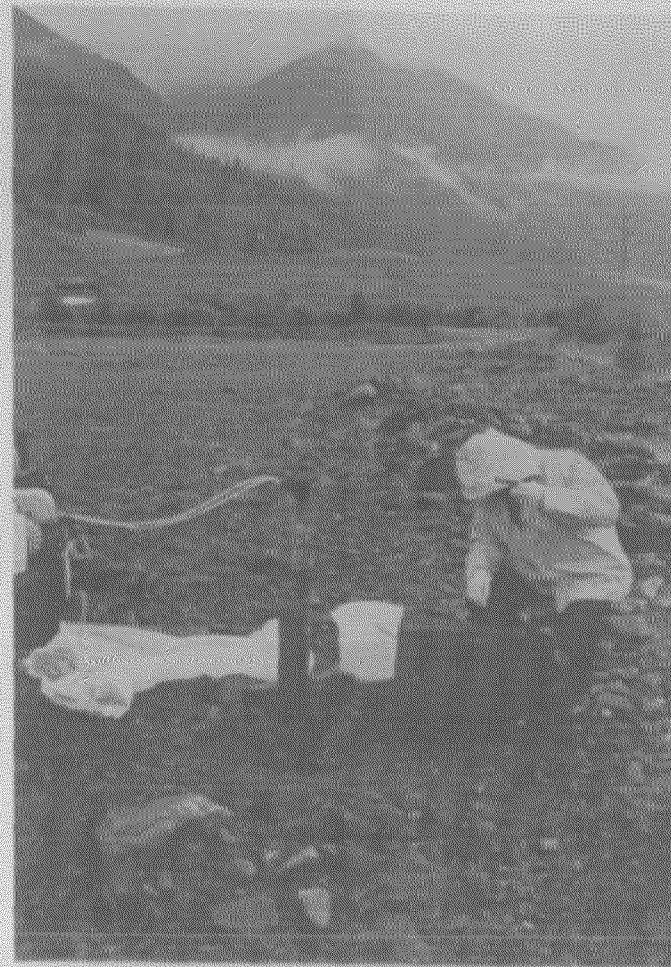
Description of Photo: GW-1 Silverton City Campground
Date: September 15, 1997 Time: 0945
Direction facing: Northwest (35mm film)

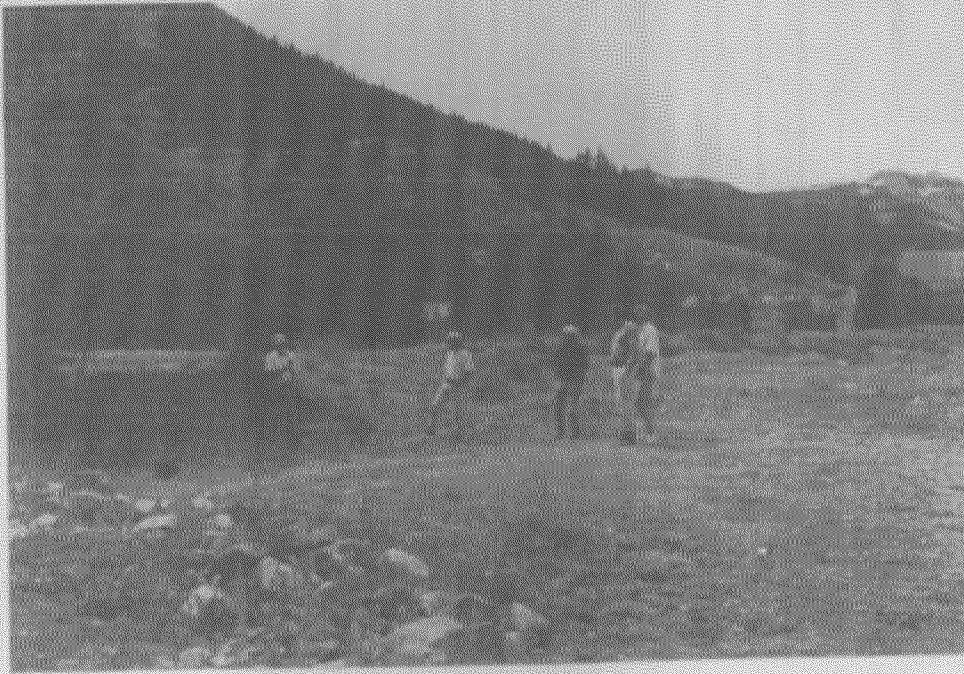
Description of Photo: GW-2 Silverton Memorial Park (Cement Creek)
Date: June 19, 1997 Time: 1430
Direction facing: Northwest (35mm film)

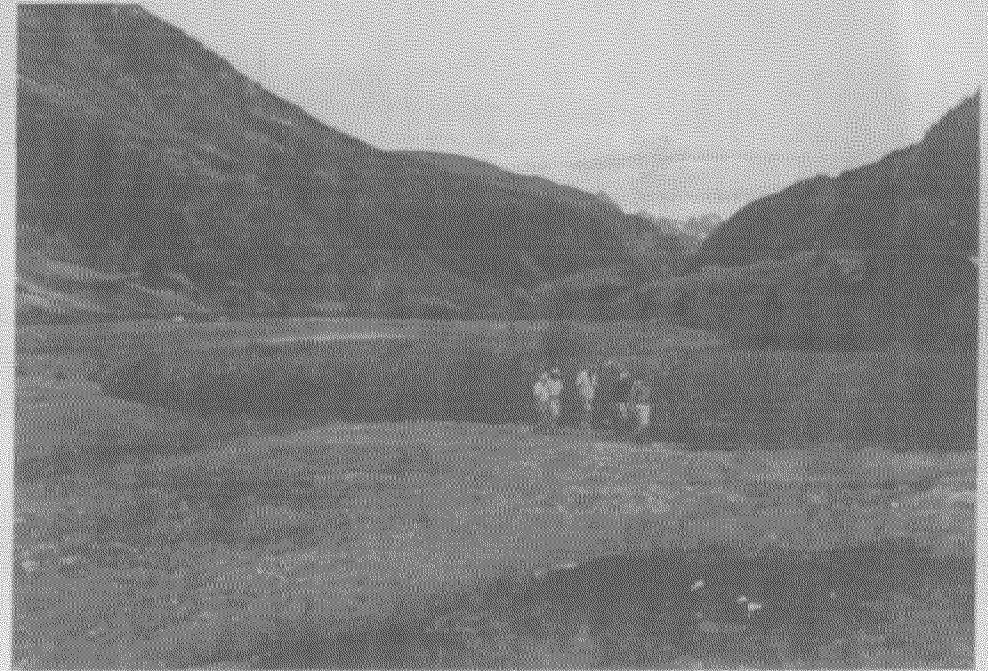
Description of Photo: GW-3 Silverton Sewage Treatment Plant (Mineral Cr.)
Date: June 19, 1997 Time: 1430
Direction facing: Southwest (35mm film)

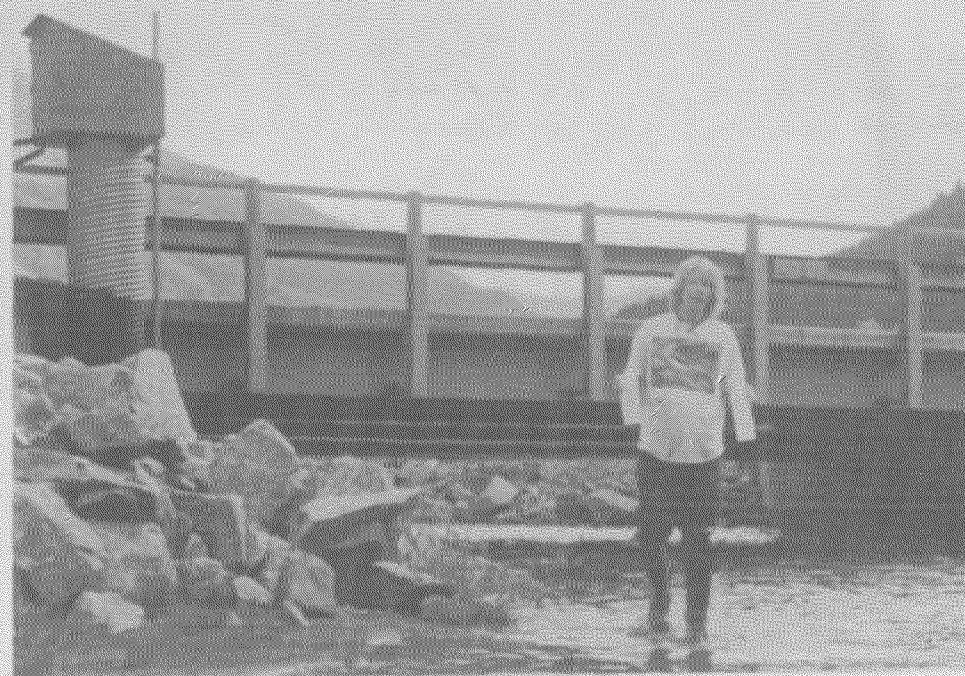
Description of Photo: SW/SE A-68 Animas River above Cement Cr. a
Date: September 4, 1997 Time: 0930
Direction facing: Northeast (35mm film)

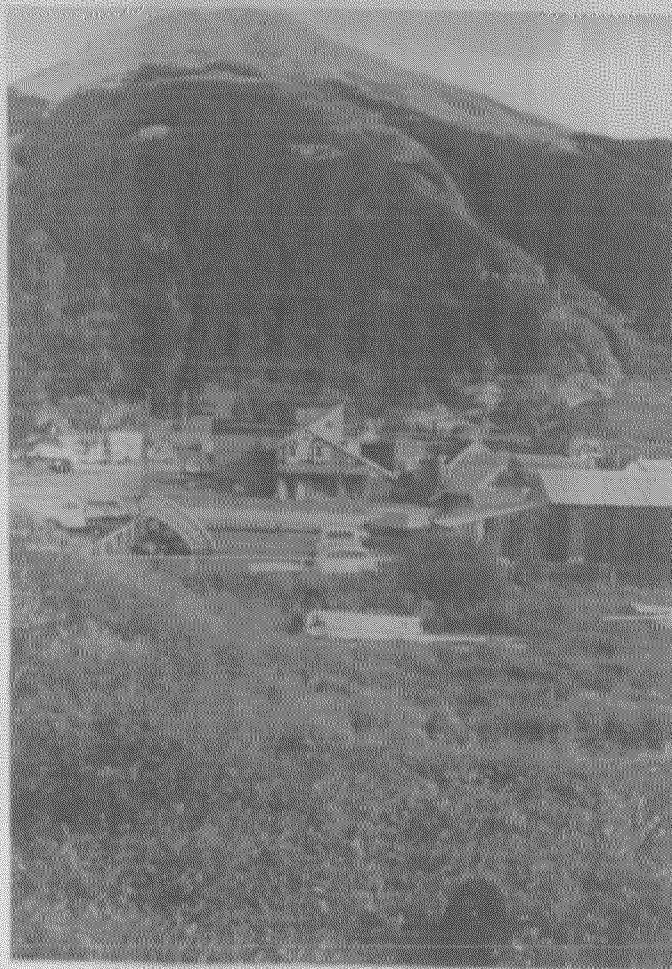
Description of Photo: OP-SL-1 Residential Soil N. of 857 Reese
Date: September 16, 1997 Time: 1715
Direction facing: East (35mm film)
